## CASE STUDY AIRPORT HOTEL

A hotel located at an airport had a tremendous problem with pigeons, sparrows and starlings.

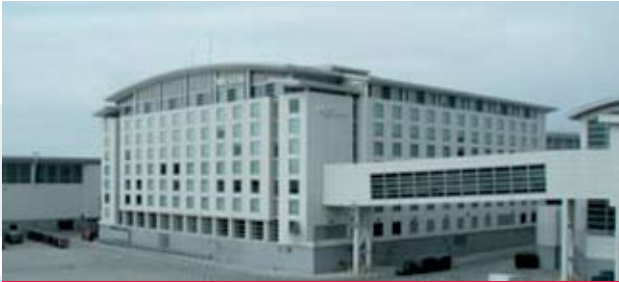
FIG 1

A hotel located at an airport had a tremendous problem with pigeons, sparrows and starlings. Birds created huge problems on signs, ledges and inside mechanical louvers.

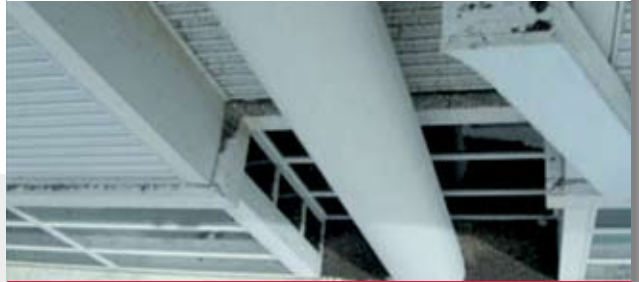
FIG 2

Ledges, louvers and sign letters are heavily coated with bird droppings. The wide ledge at the base of the white column is fouled with several inches of wet, heavy bird waste.
