Case Studies

CASE STUDY GOVERNMENT BUILDING

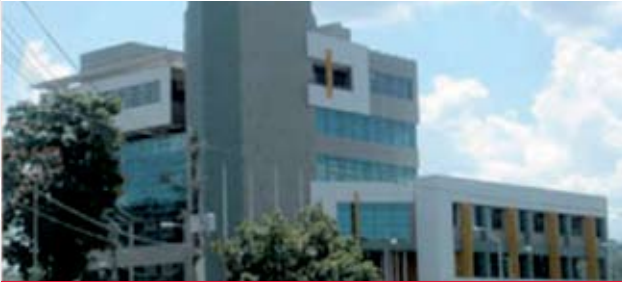
FIG 1

A large government building with a multitude of fins, ledges and other surfaces was inundated with pigeons and starlings before construction was even completed.

Flex-Track was installed throughout the facility and the bird problem was 100% eliminated. A crew of three workers spent about two weeks on the project.

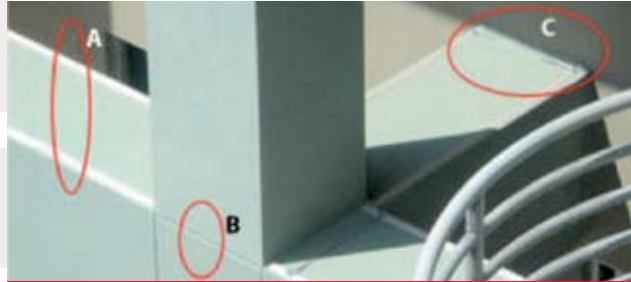
FIG 2

On visible beams, multiple rows of Flex Track were installed (A). Lead wire was glued into seams on the building (B) and painted to match. Jumper wires (C) were also painted to match.

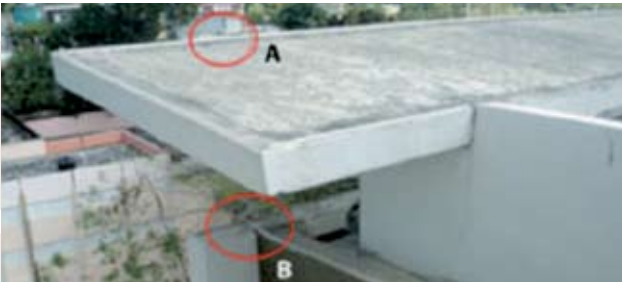
FIG 3

An upper ledge (B) is covered by a large concrete overhang (A). More than 150 metres of Flex Track are used on this part of the building. Note small jumper cable (B).

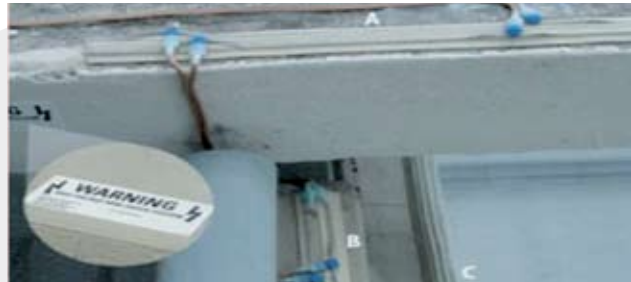
FIG 4

Warning signs are installed anywhere a worker might approach from. A clear example of the electrical pulse being routed from one track (A), to (B), and then again down to (C). After each connection the system is checked to make sure there aren't any problems. In this case the lead wire is glued to the building.

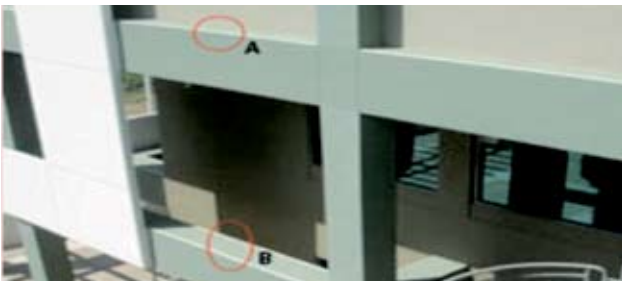
FIG 5

Single-sided ledges (A) are protected with one row of Flex-Track, while double-sided (B) are protected with two rows. Protected surfaces, like the corners, are protected with three and four rows.
