CASE STUDY SHOP

As part of a regeneration programme, 21 shop fronts were renovated with new shop signs and roller shutter. Pigeons had previously used the signs and ledges as perches causing damage to the signs as well as being health and safety hazard to the shop owners and their customers. Avishock was chosen due to its discreetness.

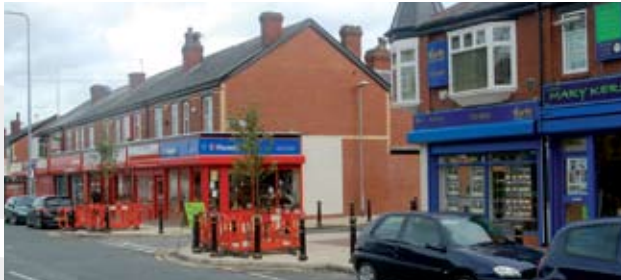
FIG 1

Three blocks of shops comprising several fast food outlets and restaurants were renovated. The casing of the roller shutters, the tops of the signs and a thin parapet wall above the signs provide the perfect perches for pigeons.

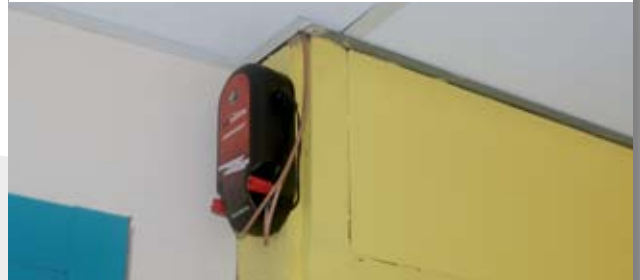
FIG 2

The Council stipulated that each shop must be responsible for the power supply to the Flex-Track. Therefore the Energiser were fitted in every shop and Lead Wire was ran to the nearest ledge. This meant that there was 21 separate 'Runs of Track'.

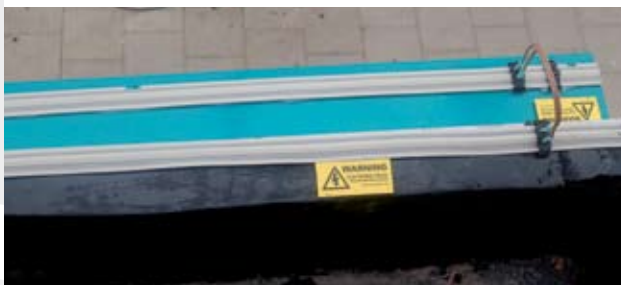
FIG 3

Flex-Track was installed as close to the leading edge as possible, however access to the screws for the signs was required. Quick Tap Jumpers were used to connect the track on the sign with the track on the parapet wall above it. Warning Plates were positioned where access to the system could be gained.

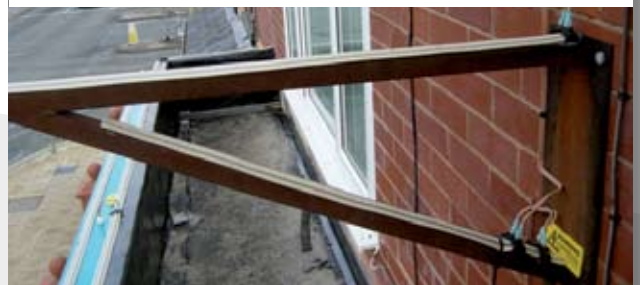
FIG 4

Surfaces above the track also needed to be protected. Flex-Track was glued to the bracket and was connected to the Lead Wire via the Connectors.

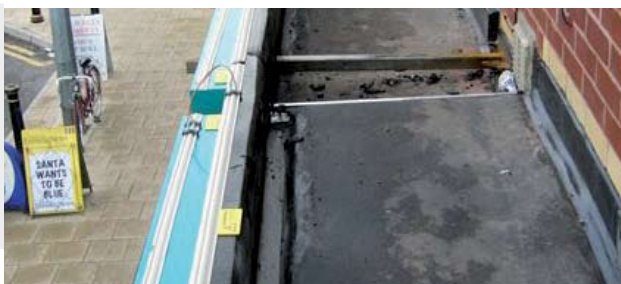
FIG 5

Avishock was installed along the entire block of shops protecting the signs and the pavement below.

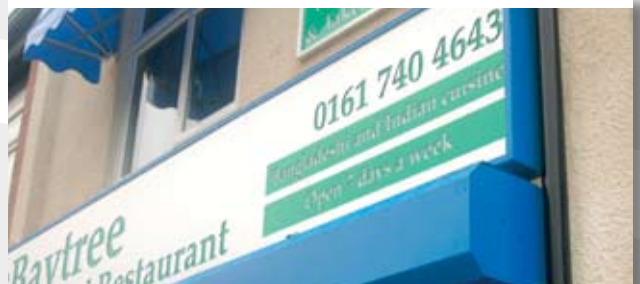
FIG 6

Looking up from the pavement, the Avishock Electric Bird Deterrent System is unnoticeable on the casing of the roller shutters and signs.
